UNITED STATES ENVIRONMENTAL PROTECTION AGENCY

SUBJ: RCRA Compliance Evaluation Inspection
Chemical Waste Management
EPA ID# ALD000622464

On November 17-20, 2015, a U.S. Environmental Protection Agency Compliance Evaluation Inspection was conducted at Chemical Waste Management in Emelle, Alabama, to determine the facility's compliance status with the Resource Conservation and Recovery Act (RCRA).

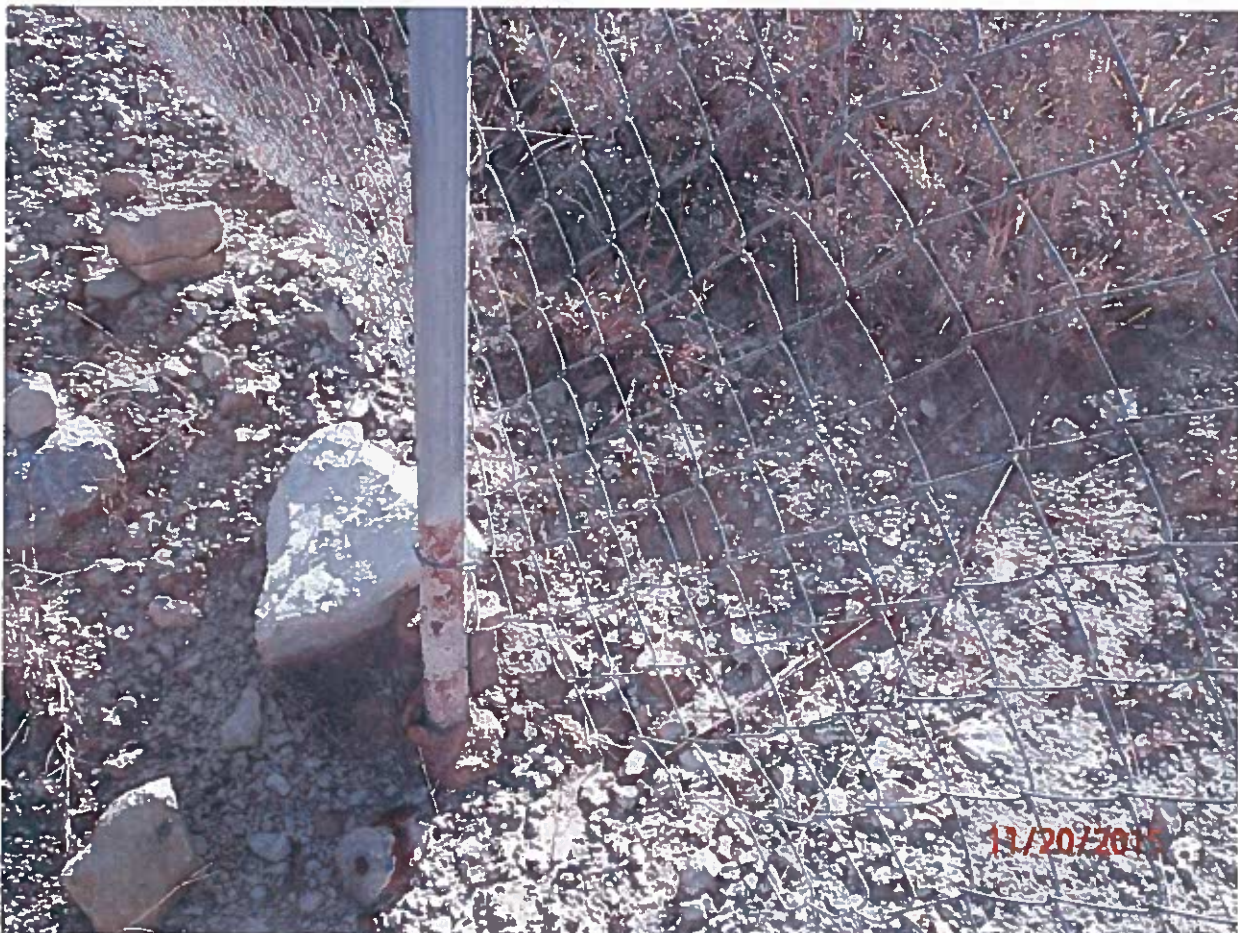
PHOTO #55

55	11/20/2015	Perimeter Fence	Section of fence with soil erosion at bottom (photo 1 of 2)
56	11/20/2015	Perimeter Fence	Section of fence with soil erosion at bottom (photo 1 of 2)
